Geo-Environmental and Geo-Technical Baseline Assessment

Halsnead Masterplan SPD

January 2017

Knowsley Metropolitan Borough Council

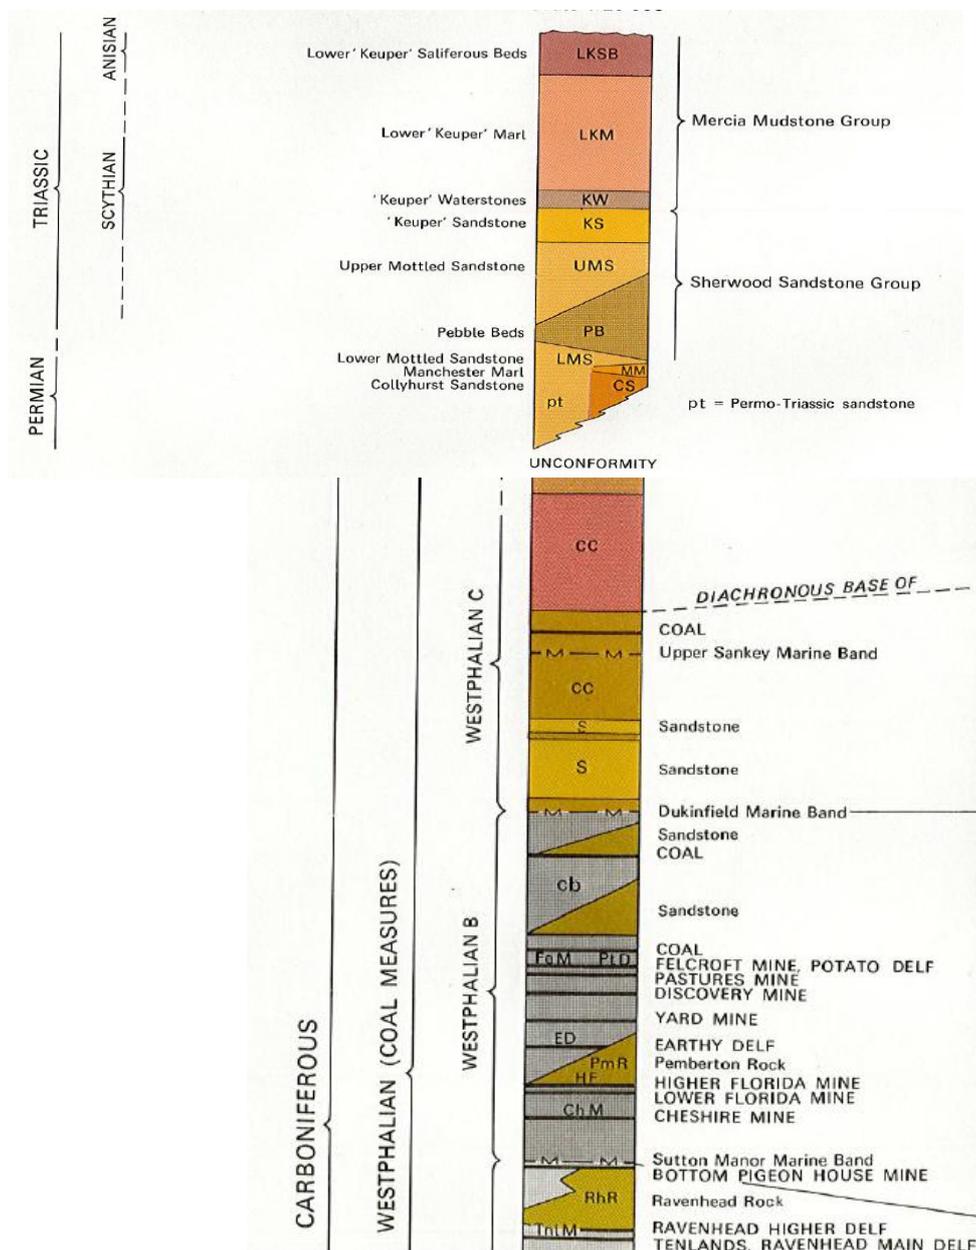
Figure 2.2: Excerpt of key from BGS Geological Mapping (Solid Geology)

Source: Extract from Geological Survey of Great Britain (England and Wales): Runcorn Sheet 97 1:50,000 Series Solid Edition. Reproduced with the permission of the British Geological Survey ©NERC. All rights Reserved.

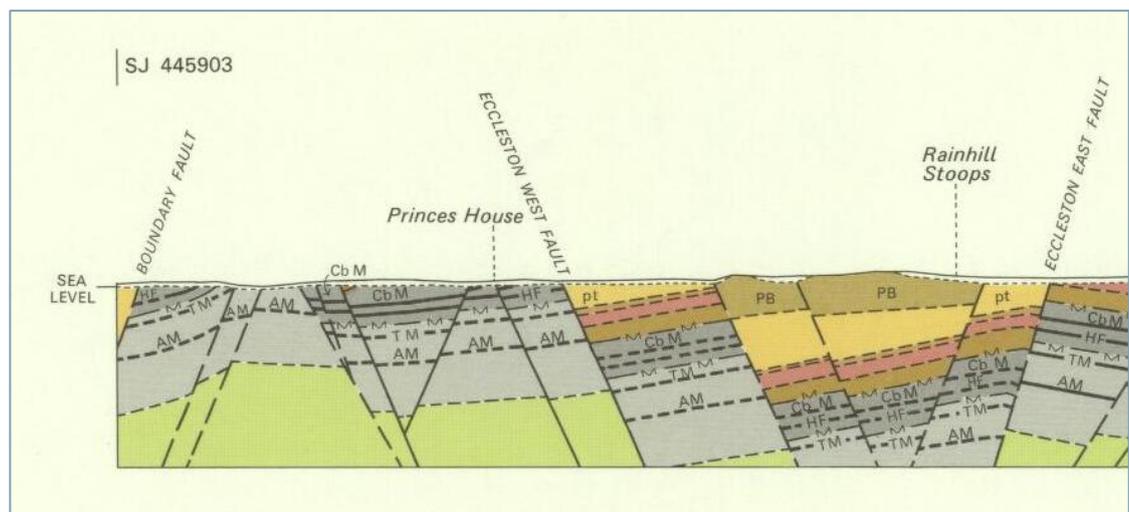
Figure 2.3: Excerpt of Cross-Section from BGS Geological Mapping

Source: Extract from Geological Survey of Great Britain (England and Wales): Runcorn Sheet 97 1:50,000 Series Solid Edition. Reproduced with the permission of the British Geological Survey ©NERC. All rights Reserved.

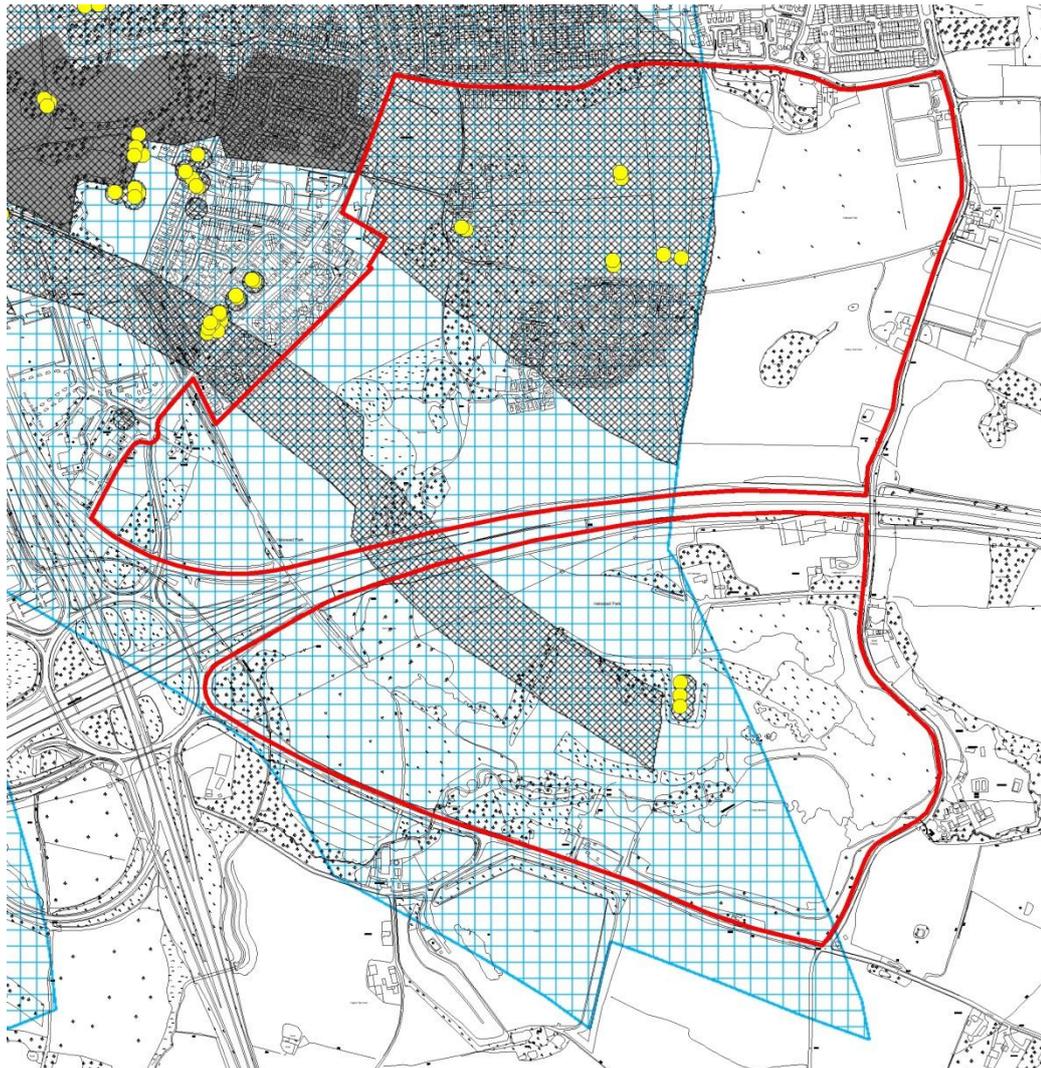
Figure 2.4: Local Area Coal Mining Feature Location Plan

- 2.5.1 A summary of the key coal mining features across the SUE and local area is provided within Figure 2.4.

Source: Data provided by KMBC and the Coal Authority Web Mapping Service.

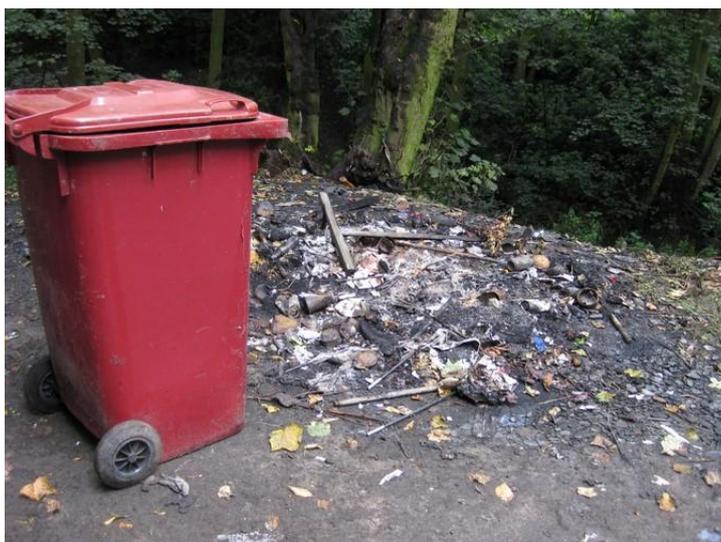
Figure B.2: Evidence of waste burning in The Old Wood

security fencing) with a children's play area beyond. Crossing the Main Drive, west of the mobile home park is a small drain which flows into a north-south elongated pond. From here the water flows southward via a small stream into 'Big Water' a relatively large lake (formerly the boating lake for Halsnead House) which outflows to the south via a small stream. The area surrounding the surface water features is heavily wooded with 'Round Clump' to the west of Big Water and 'The Old Wood' to the south. During the site walkover fly tipping was noted to be prevalent throughout The Old Wood and adjacent to Big Water with evidence of rubbish being burned.

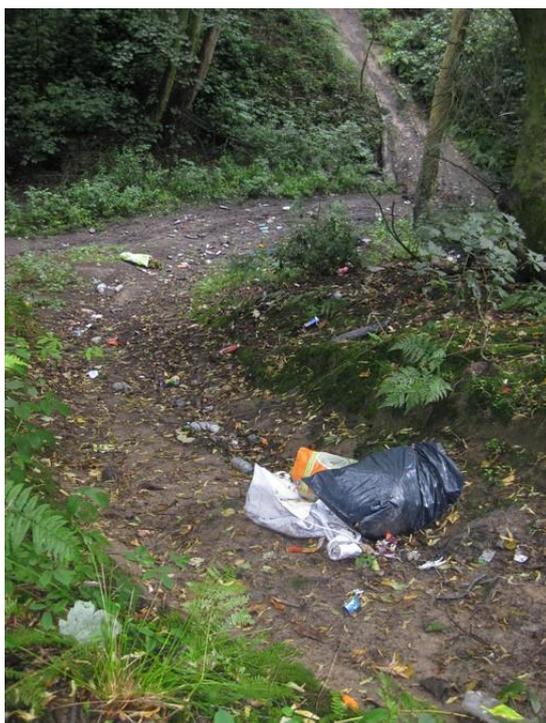
Figure B.3: Looking west down towards a small bridge of the watercourse running through The Old Wood with evidence of fly tipping in the foreground

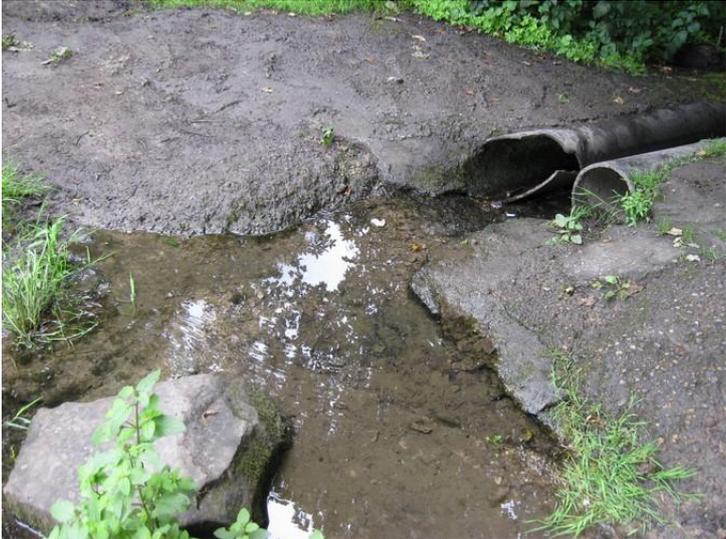
Figure B.6: Outfall from Big Water

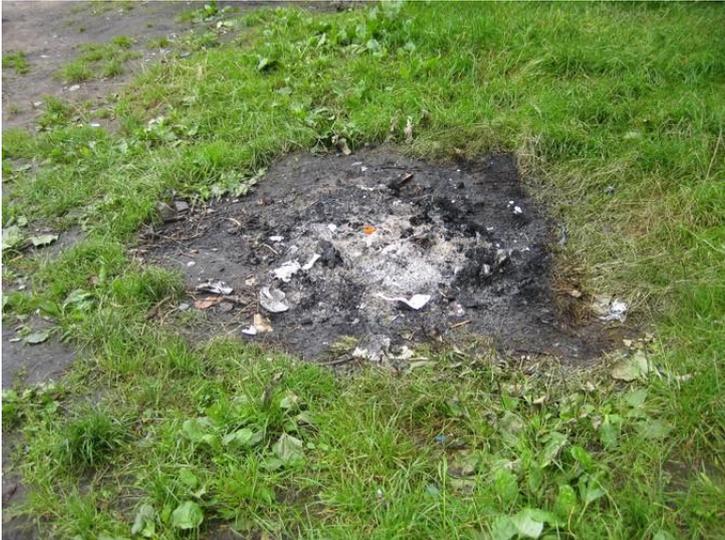
Figure B.7: Additional evidence of waste burning

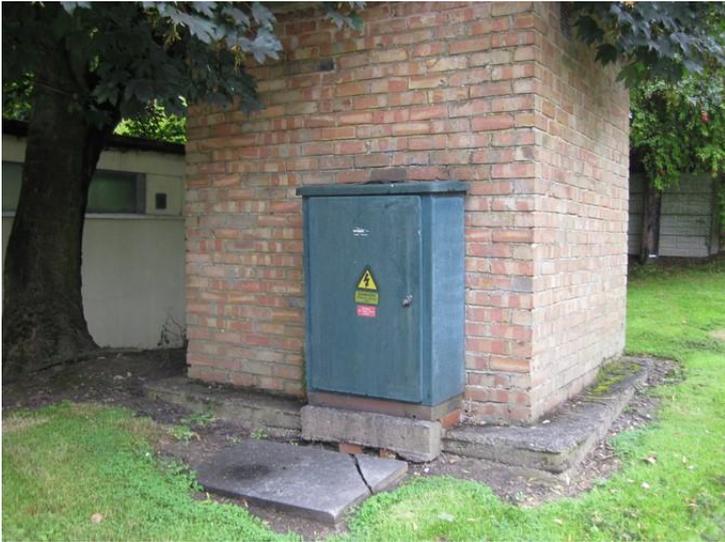
Figure B.9: Looking north at assumed substation building within mobile home park

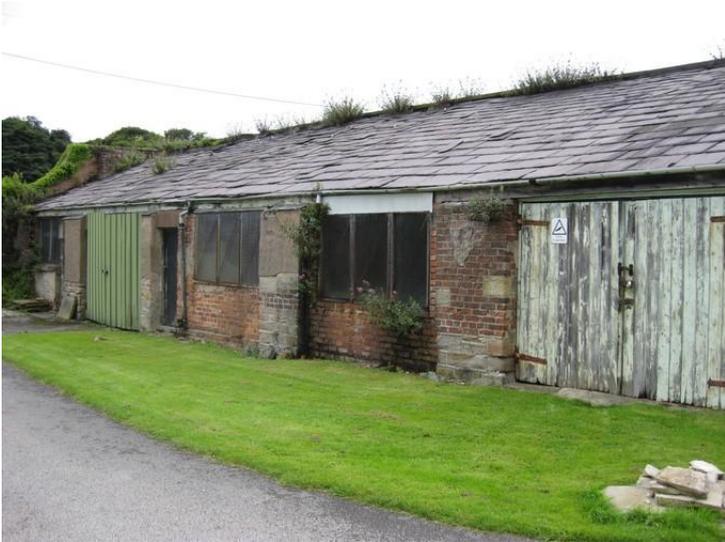
Figure B.10: Looking north-west at remains of Halsnead House outbuildings within mobile home park

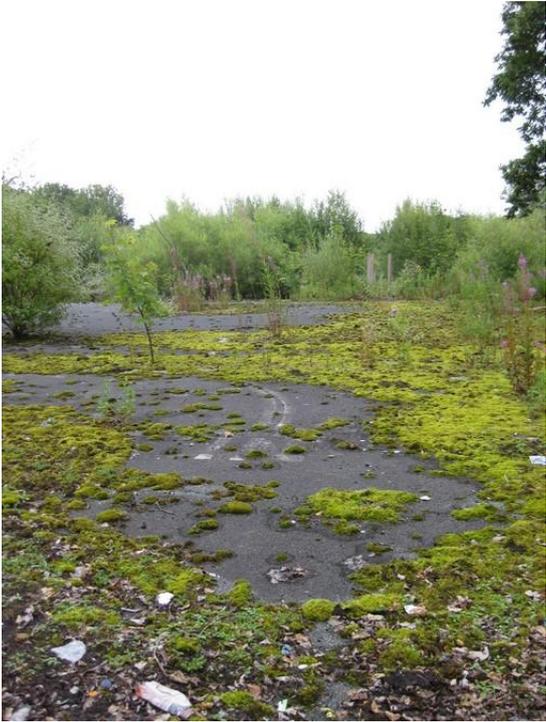
Figure B.15: Looking east across former nursery site to south of Main Drive

2.1.5 To the south of the Main Drive where it enters the site is the disused site of a former nursery (a large area of poor quality black top was observed through

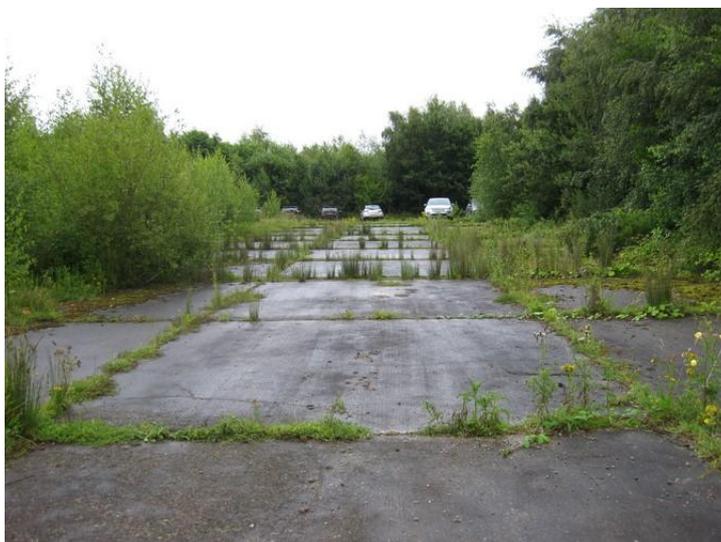
Figure B.16: Looking north-east across hardstanding area at former Cronton Colliery entrance (assumed to be associated with former administrative buildings)

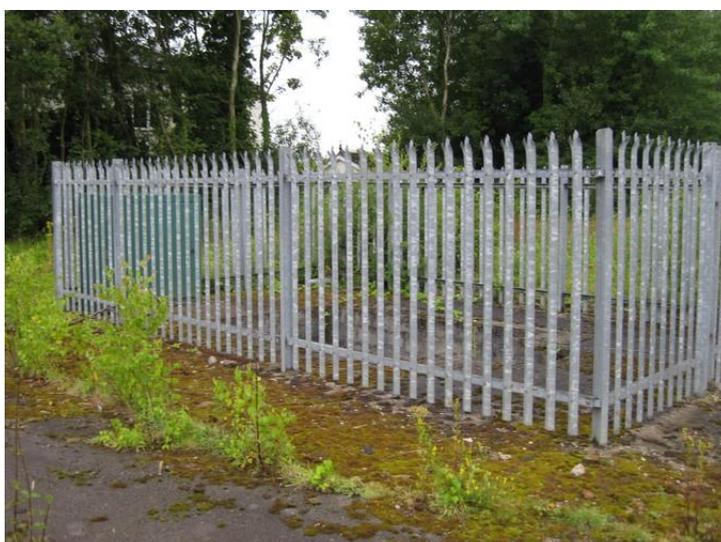
Figure B.17: Looking west at small package sewerage treatment plant

administrative buildings and parking. To the north of Park Villas in a fenced compound is a small package sewerage treatment plant serving the adjacent propertiesⁱⁱ. Brick structures containing water (with deep water warning signs) were observed assumed to be overflows, along with canalised sections of Fox’s Bank Brook. Across the plateau areas coal fragments were present at the surface.

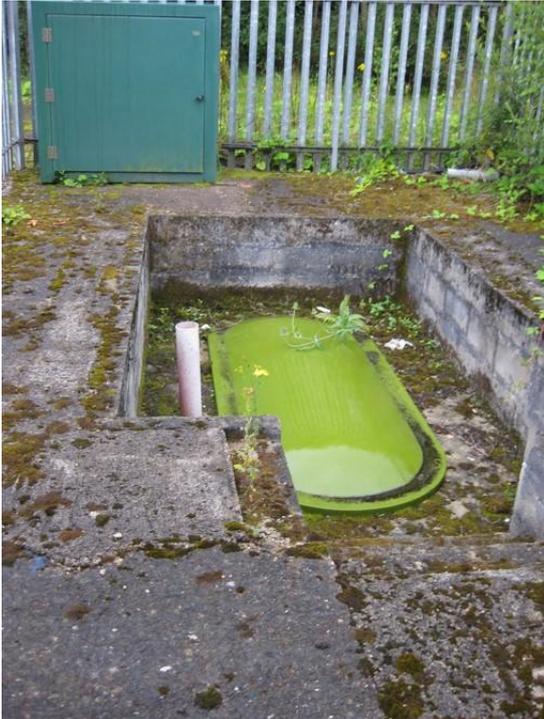
Figure B.18: Looking south at small package sewerage treatment plant

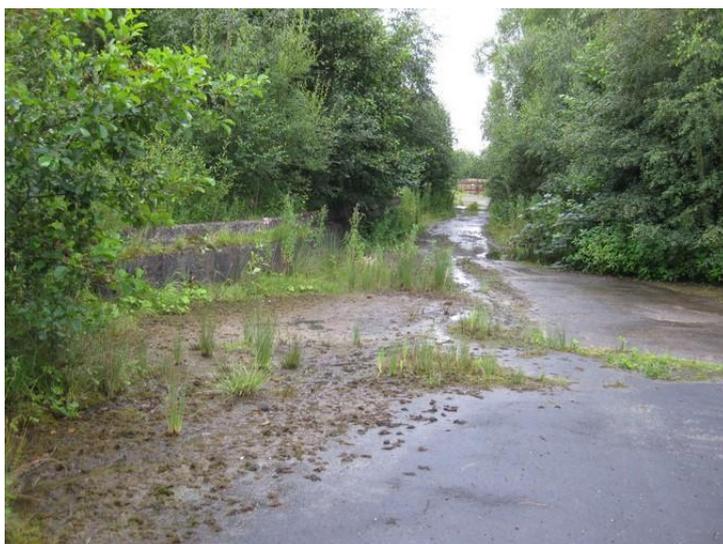
Figure B.20: Looking west along access track through former Cronton Colliery site, showing standing water and boggy conditions to left

- 2.7.6 On the day of the site visit standing water and very boggy areas (there had been a period of moderately wet weather) were noted throughout the former colliery site. The direction of surface water flow across the site is considered to be from the north-east to the south-west.

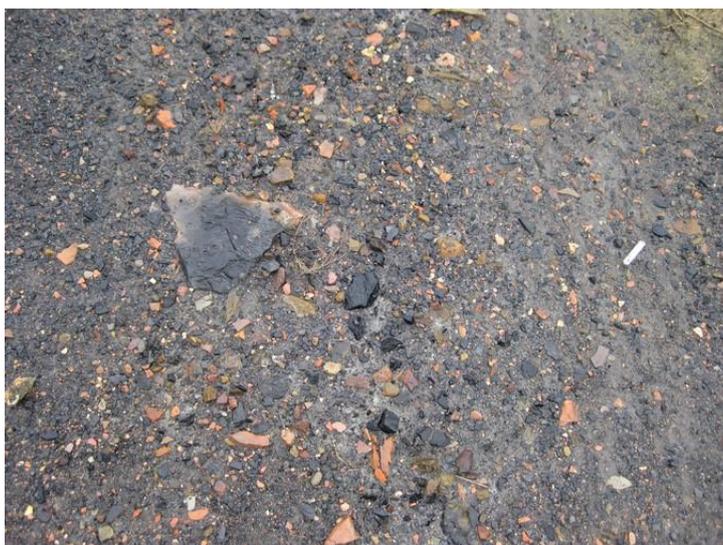
Figure B.21: Coal fragments present across the colliery spoil plateau

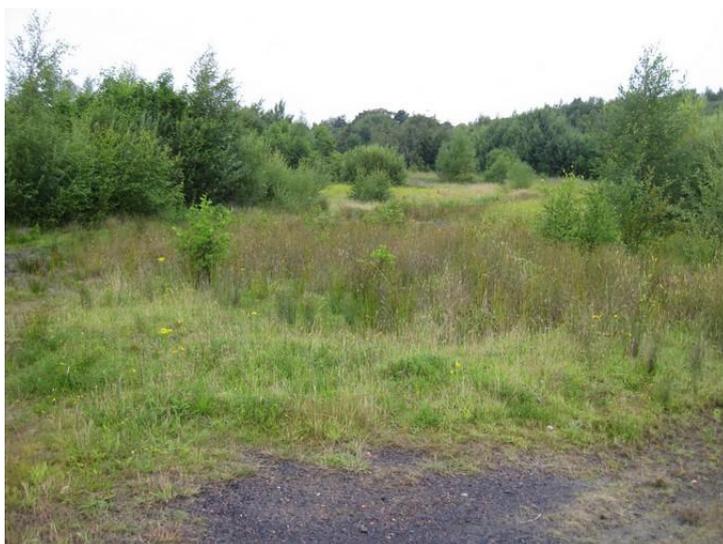
Figure B.22: Looking north towards location of three capped former Cronton Colliery shafts

- 3.5.29 Given the previous investigations into the commercial extraction of gas from the shaft locations, the flow rates observed were not considered to be significant and Parkman concluded that the shafts are the main conduit for the mine gas to rise to the surface.

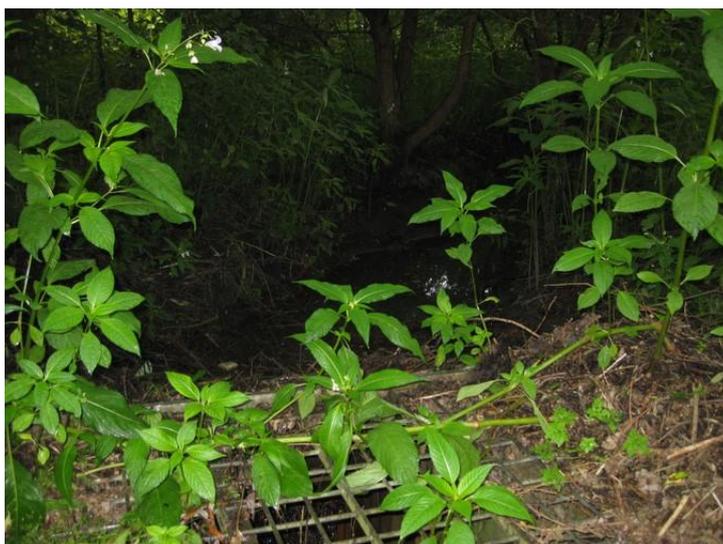
Figure B.23: Looking east at overflow and Fox's Bank Brook to west of colliery spoil plateaux

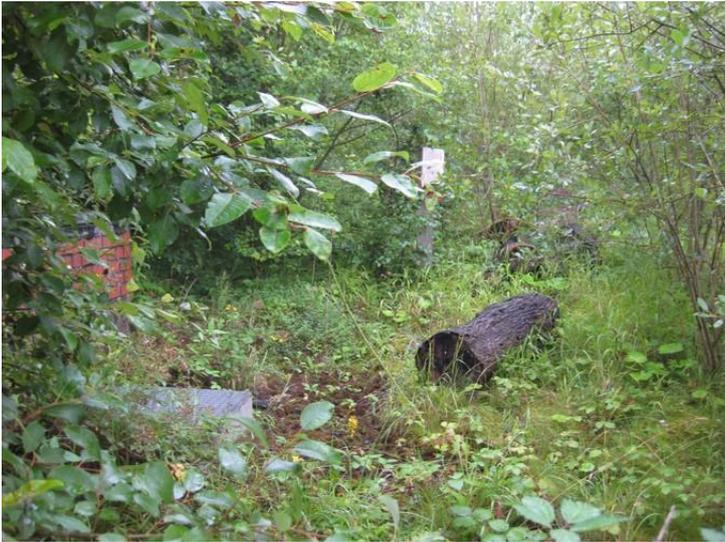
Figure B.24: Looking north-east towards an additional brick structure (overflow) and deep water warning sign

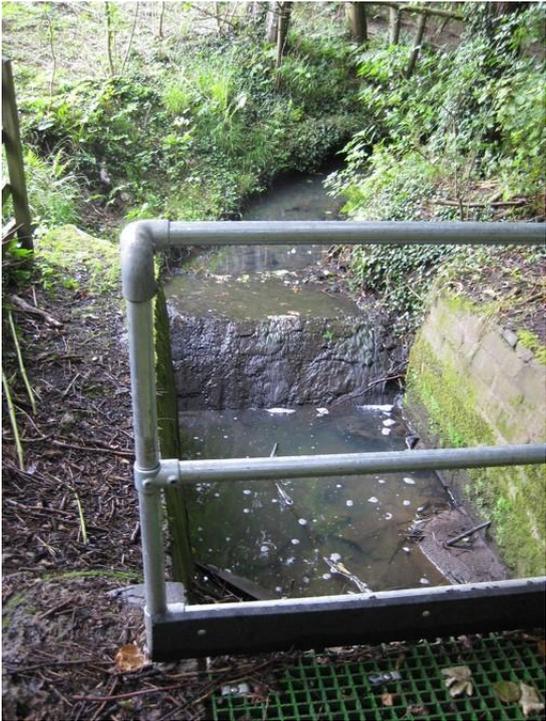
Figure B.25: Looking north where Fox's Bank Brook crosses the A5080 (Cronton Road Debris Screen)

- 2.1.15 Fox’s Bank Brook passes through ‘Cronton Road Debris Screen’ when passing under the A5080. To the north-west of this, widespread Himalayan Balsam was noted.

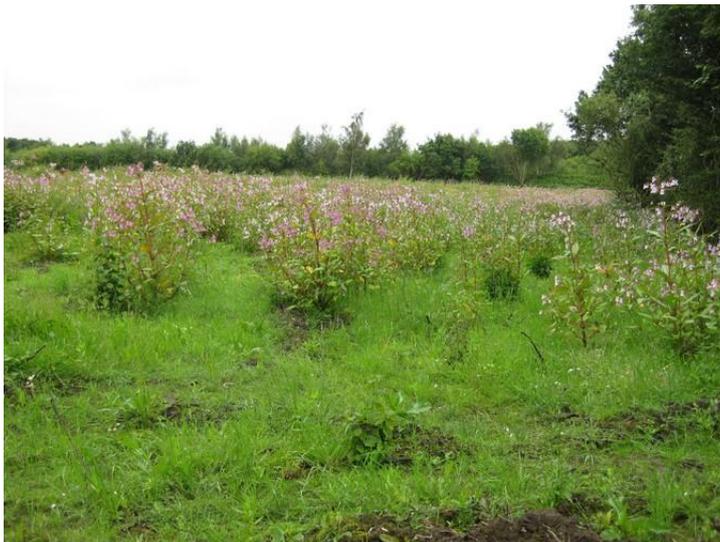
Figure B.26: Looking north-east across farmland to west of Fox's Bank Brook with extensive Himalayan Balsam
